LANDSLIDES AND RELATED FEATURES

OF THE GOSHEN, W. VA. QUADRANGLE

GREGORY C. OHLMACHER

OPEN FILE MAP 83-80 (F-14)

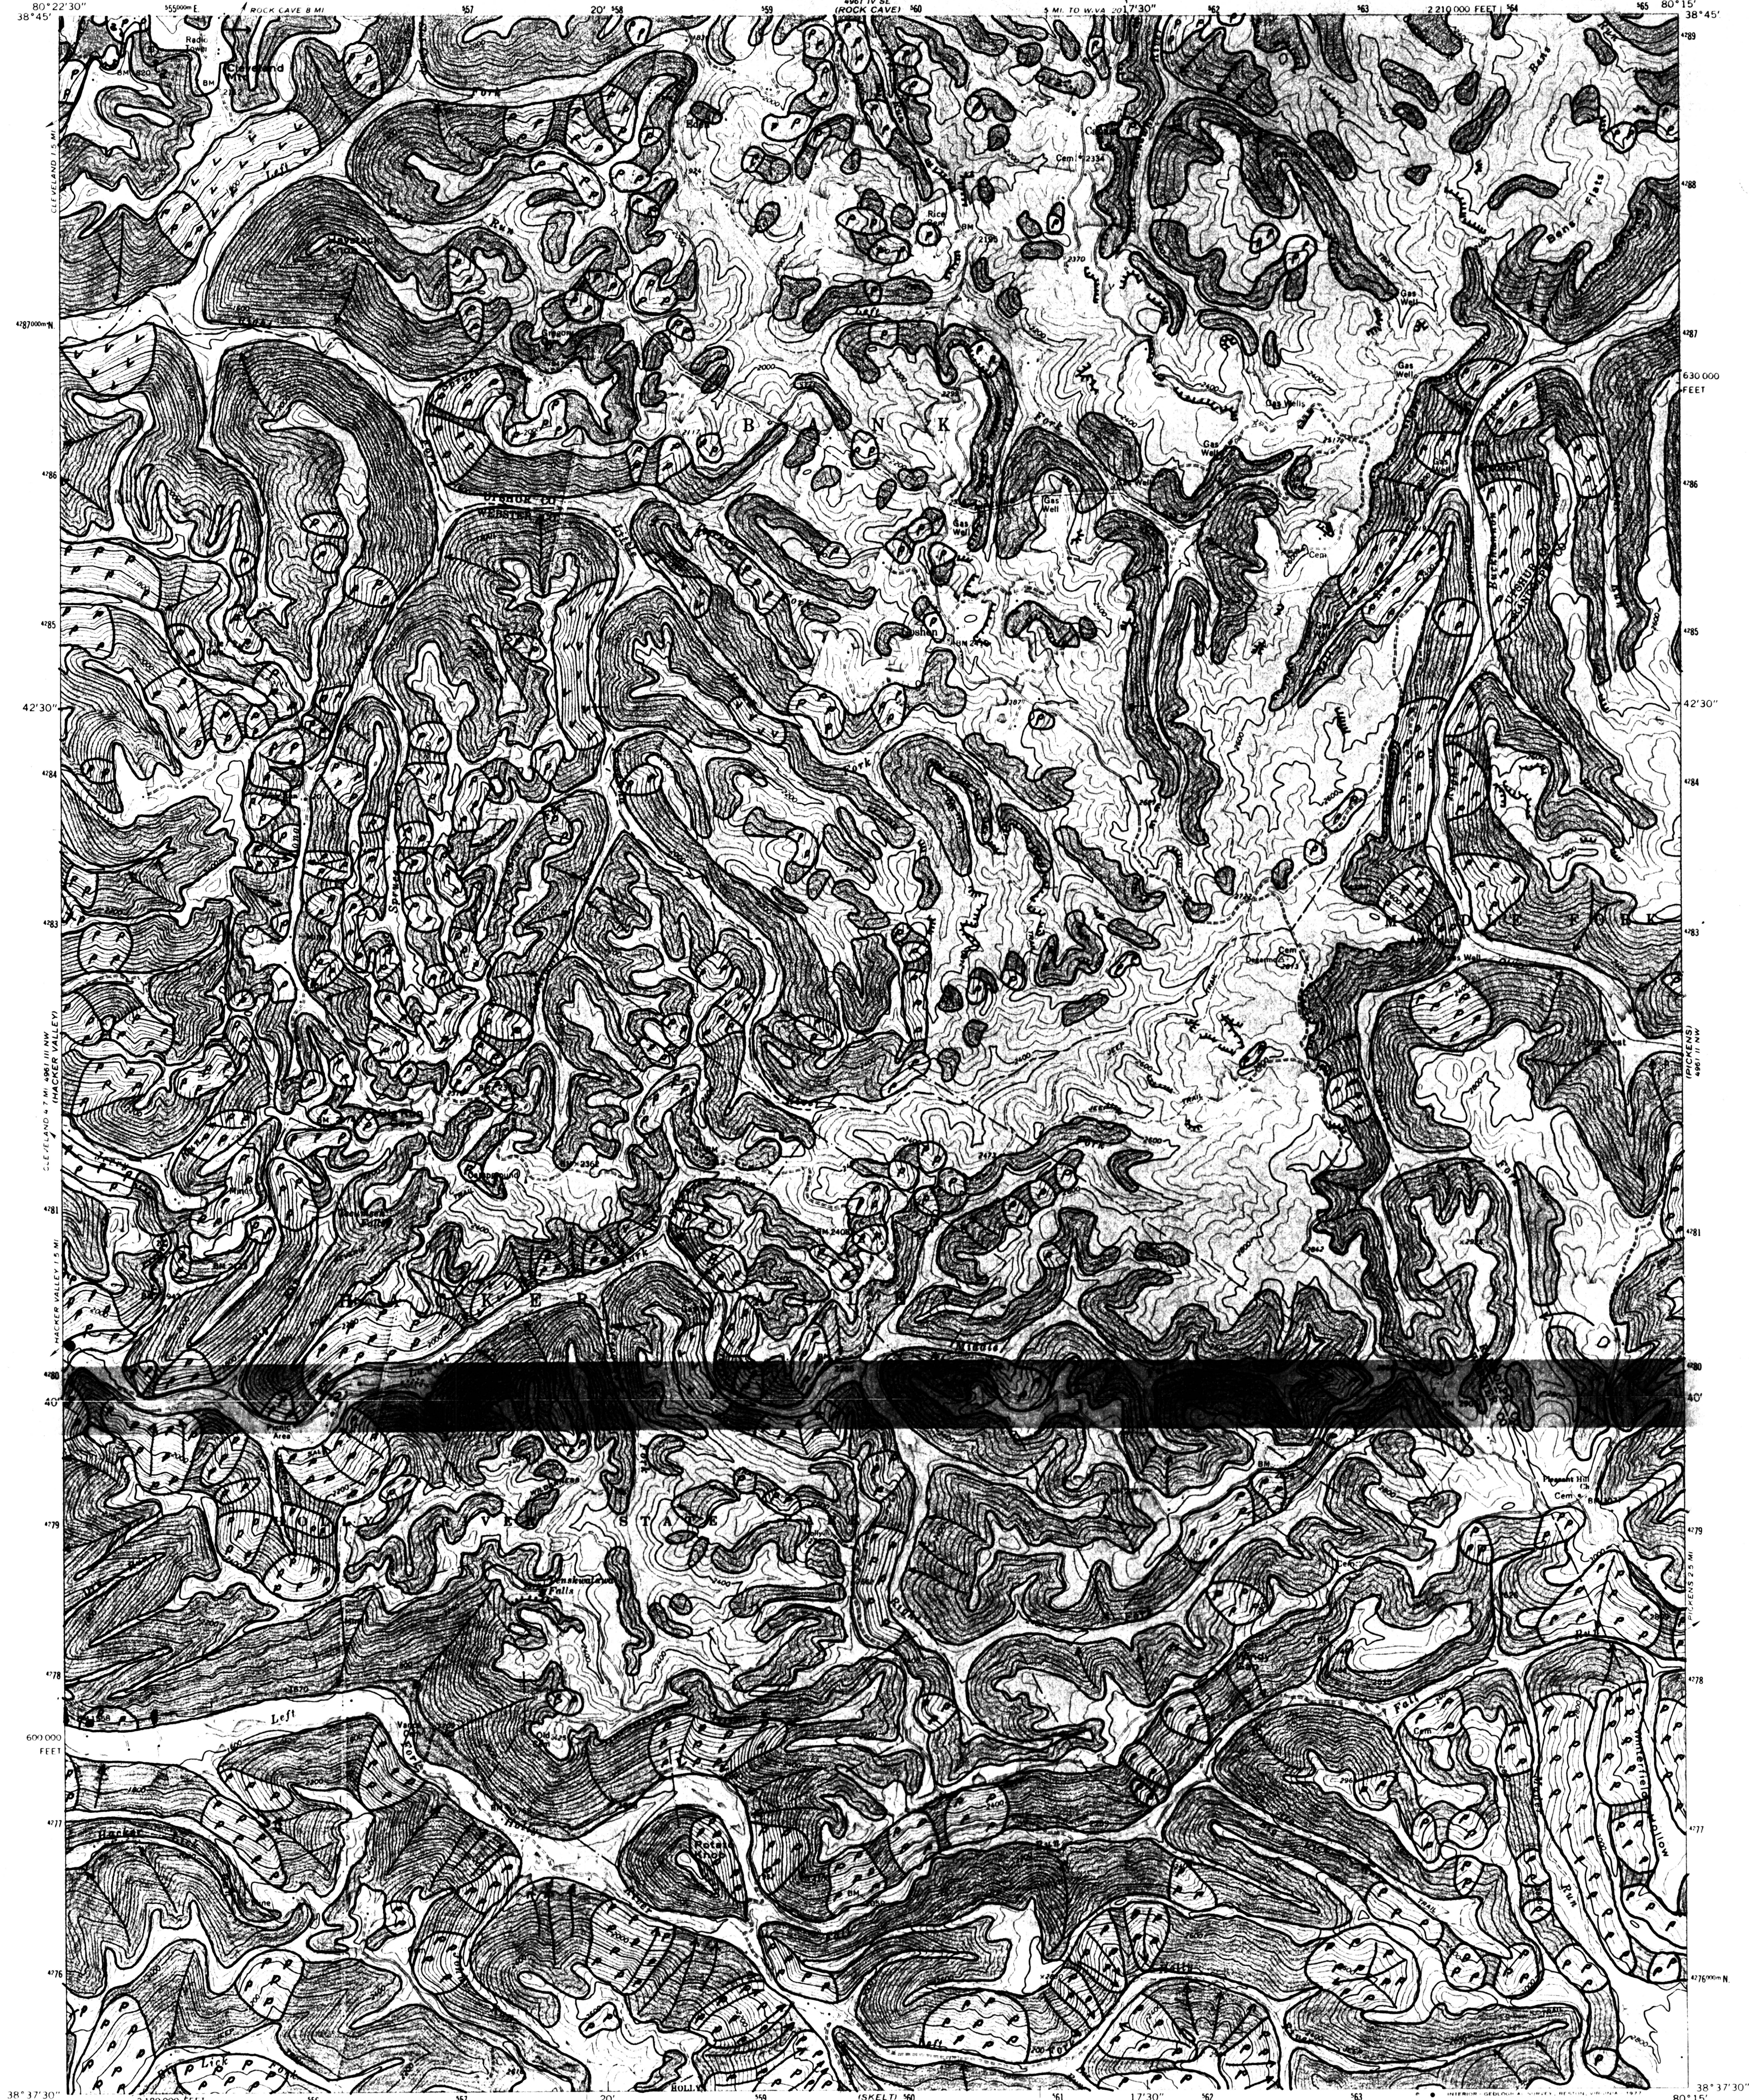
GOSHEN, W. VA.
NE 1/4 HACKER VALLEY 15 QUADRANGLE
N 38° 37' 30" — W 80° 15' 15"

ACTIVE OR RECENTLY ACTIVE LANDSLIDE
Complex landslide composed of earthflow, debris
slide, earth and rock slump. Identified from
historical records, and from scars, debris and
other field evidence. Ground extremely unstable,
sliding accelerated by excavation, loading and
changes in drainage conditions. May include
areas with several active slides too small to
be shown separately.

OLD LANDSLIDE
Area of extensive hummocky ground caused by
earthflow and earth and rock slump. Lacks
clear evidence of active sliding. Relatively
stable in natural, undisturbed state,
generally not affected by small structures properly
sited in areas away from the edge of the toe,
can be reactivated by extensive, rapid exca-
vation, loading, and changes in ground water and
surface water conditions. Area of old landslide
probably includes recent ones not identified
from field evidence or otherwise documented.
Upslope boundary of landslide generally defined
by modified scarp, but downslope (toe) may be
gradational and not well defined.

COLLUVIAL SLOPE
Valley wall along major streams with slope as
steep as 40° (85%), stony, clayey silt soil up
to 50 ft. (15 m) thick, commonly buttressed by
a terrace or bench at the toe of the slope, very
susceptible to sliding by cutting of toe area,
removal of terrace or bench, and overloading,
slide commonly activated without apparent cause.

**AREAS SUSCEPTIBLE TO DEBRIS FLOWS AND DEBRIS
AVALANCHES**
Primarily shallow, narrow ravines and chutes with
accumulation of stony colluvium generally 10 ft.
(3 m) or less in thickness, susceptible to rapid
movement during intense rainfall. Most ravines
and chutes designated show evidence of former
debris flows and avalanches. Symbol 'a' desig-
nates historical debris flow or debris avalanche.

AREAS SUSCEPTIBLE TO ROCKFALL
Steep, locally vertical, natural and man-made
slopes and cliffs, 15 ft. (4.5 m) or more high,
formed dominantly of sandstone, limestone, sandy
shale, mudstone and claystone. Interbedded mud-
stone, claystone and shale weather rapidly leaving
sandstone and limestone rock faces unsupported.

SOIL AND ROCK SUSCEPTIBLE TO LANDSLIDING
Soil and rock similar to that involved in land-
slides elsewhere in map area; primarily areas
underlain by claystone, mudstone and shale
associated with other rock types. Rock weathers
rapidly on exposure forming clayey soil highly
susceptible to sliding. Includes coves (U-shaped,
shallow valleys) containing thick layers of clayey
soil that are very susceptible to sliding where
excavation breaks continuity of slope and where
overloaded by artificial fill.

AREAS LEAST PRONE TO LANDSLIDES
Map areas in which no patterns or symbols are shown;
primarily valley floors, ridge tops and broad
benches; modification by excavation and fill may
lead to local landslides.
